**UNITED STATES BANKRUPTCY COURT  
FOR THE DISTRICT OF DELAWARE**

US MAGNESIUM LLC,

**UTAH DIVISION OF FORESTRY, FIRE, AND STATE LANDS’  
OBJECTION TO DEBTOR’S NOTICE OF DE MINIMIS ASSET SALE  
FILED AT DOCKET NO. 999**

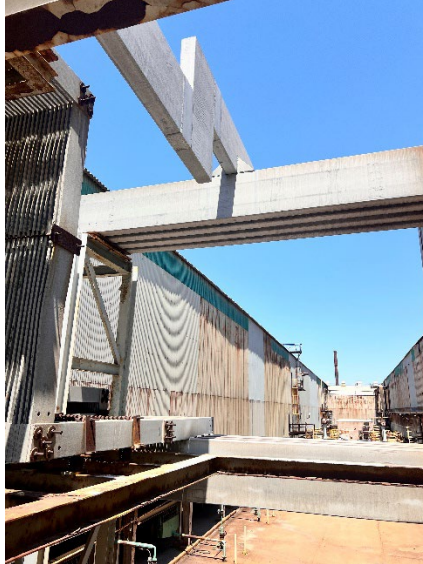
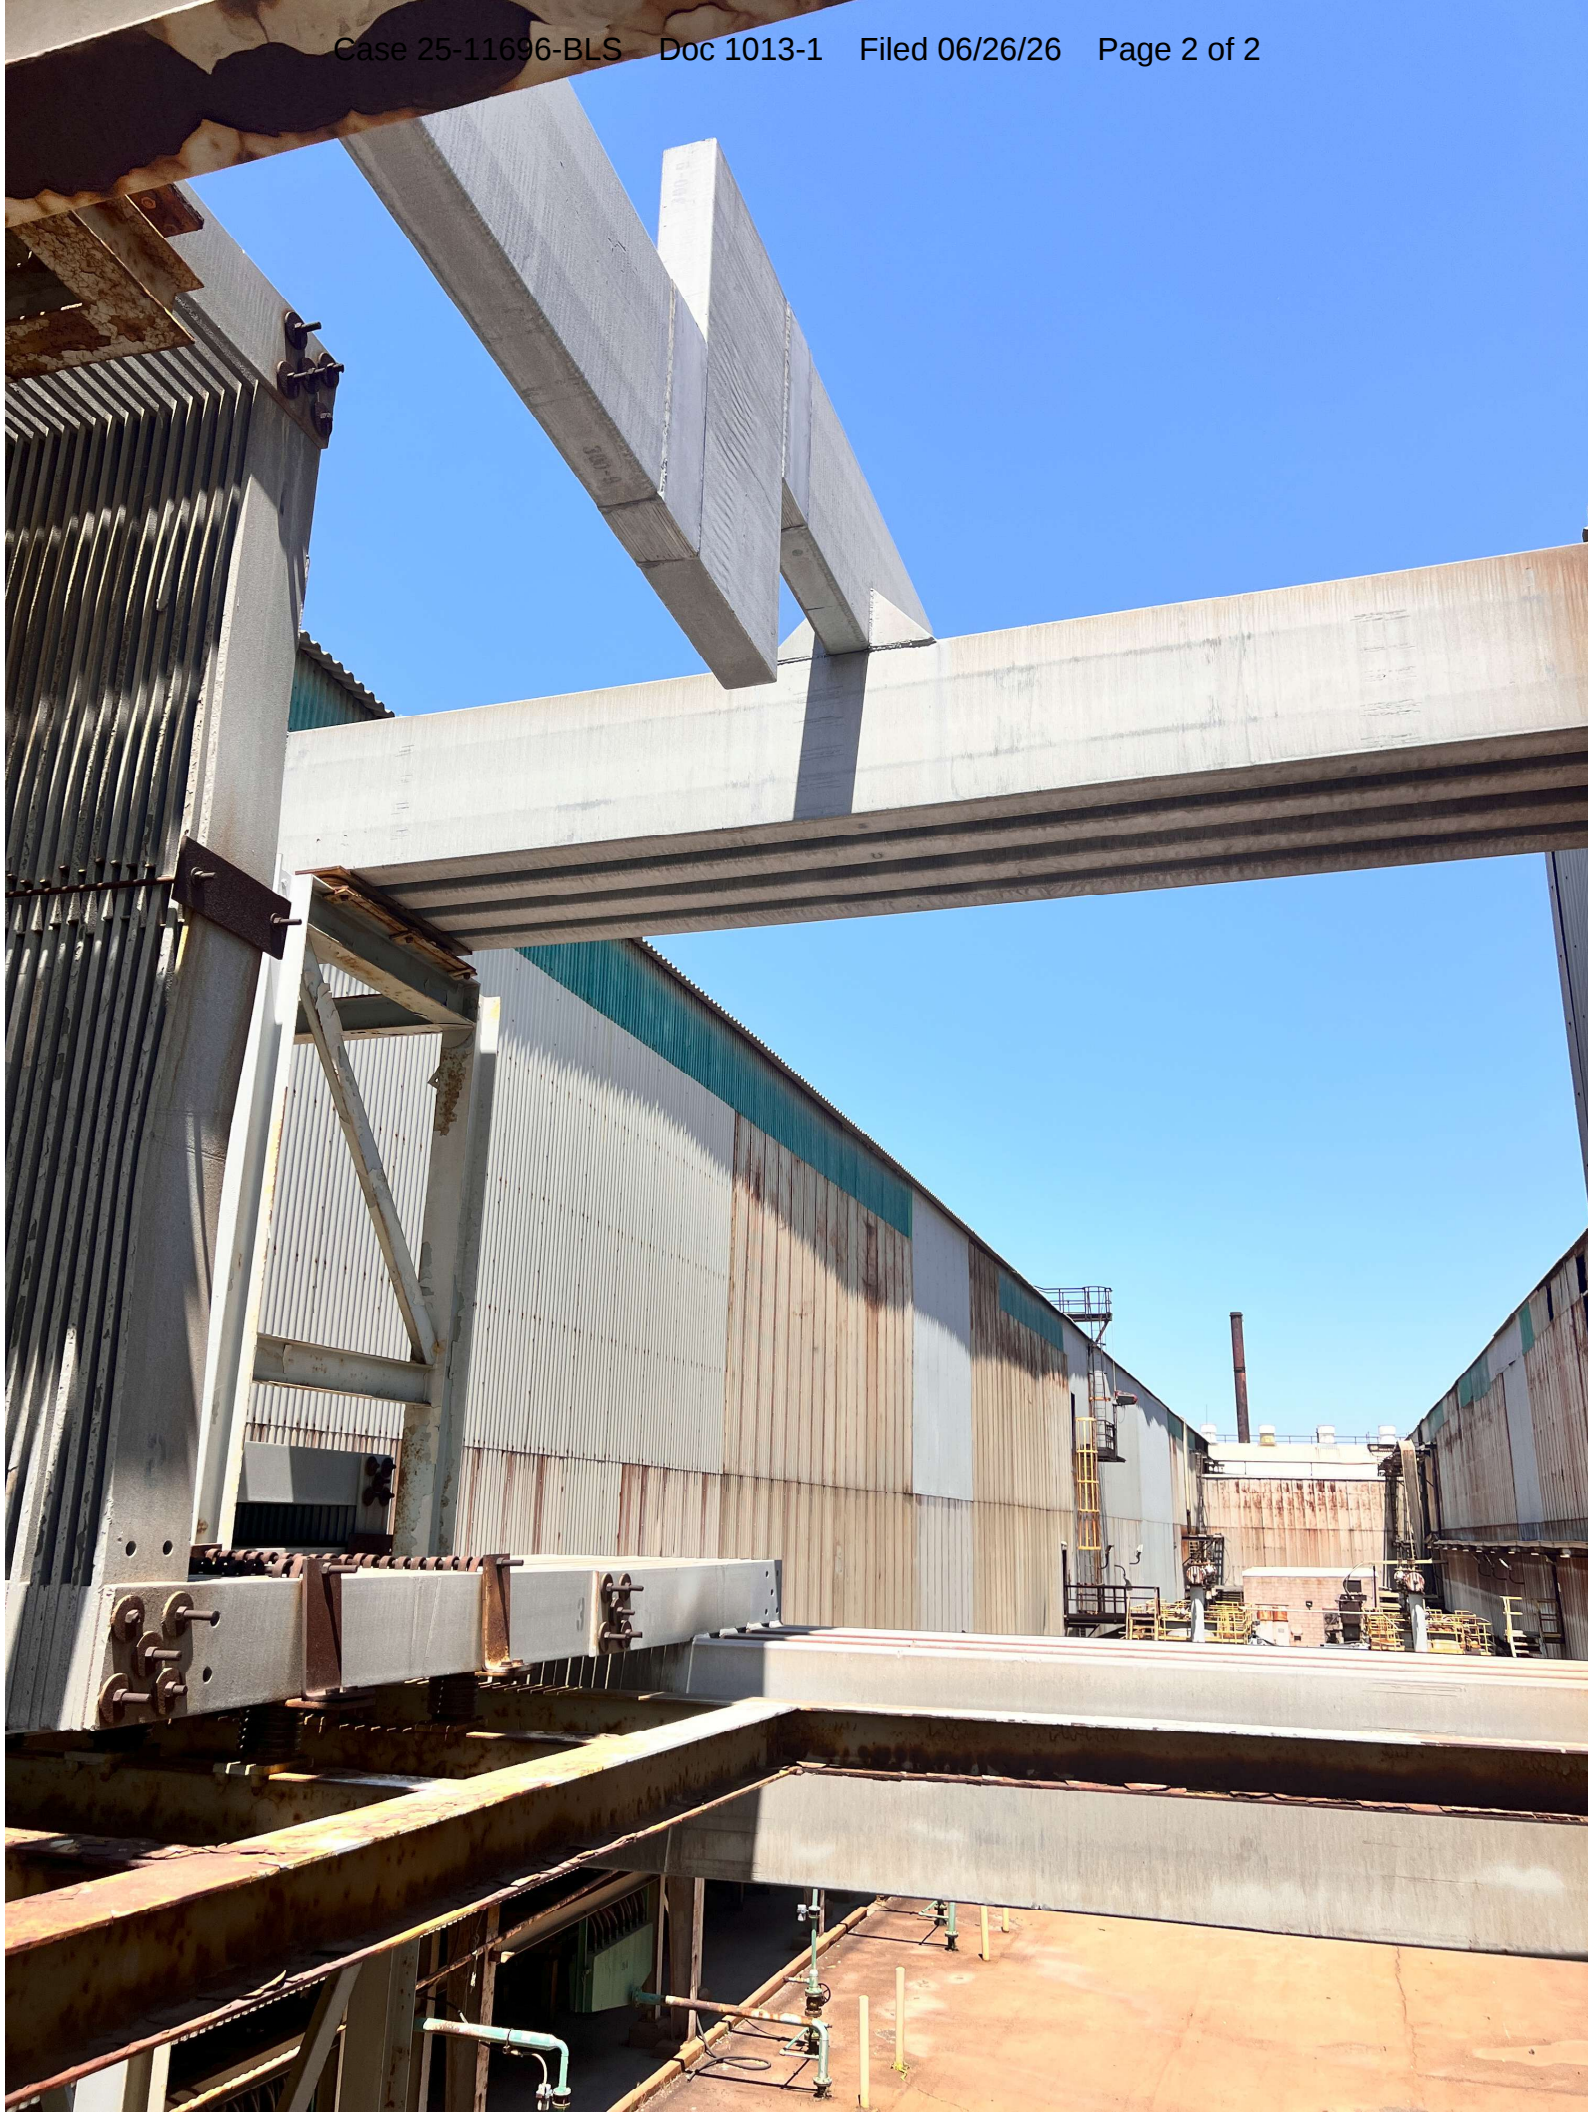
# **EXHIBIT 1**

14. The Bus Bar in the facility is welded together to form one unit throughout the facility. The Bus Bar runs through the walls, in or around the floor and ceiling, and between four wings of the facility that contain electrolytic cells. Below, and attached as Exhibit "1", is an image that shows the Bus Bar running between two wings of the facility – "Magnesium Building One" and "Magnesium Building Two".

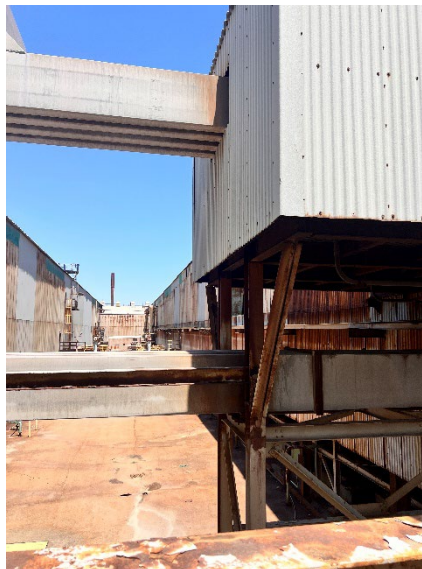
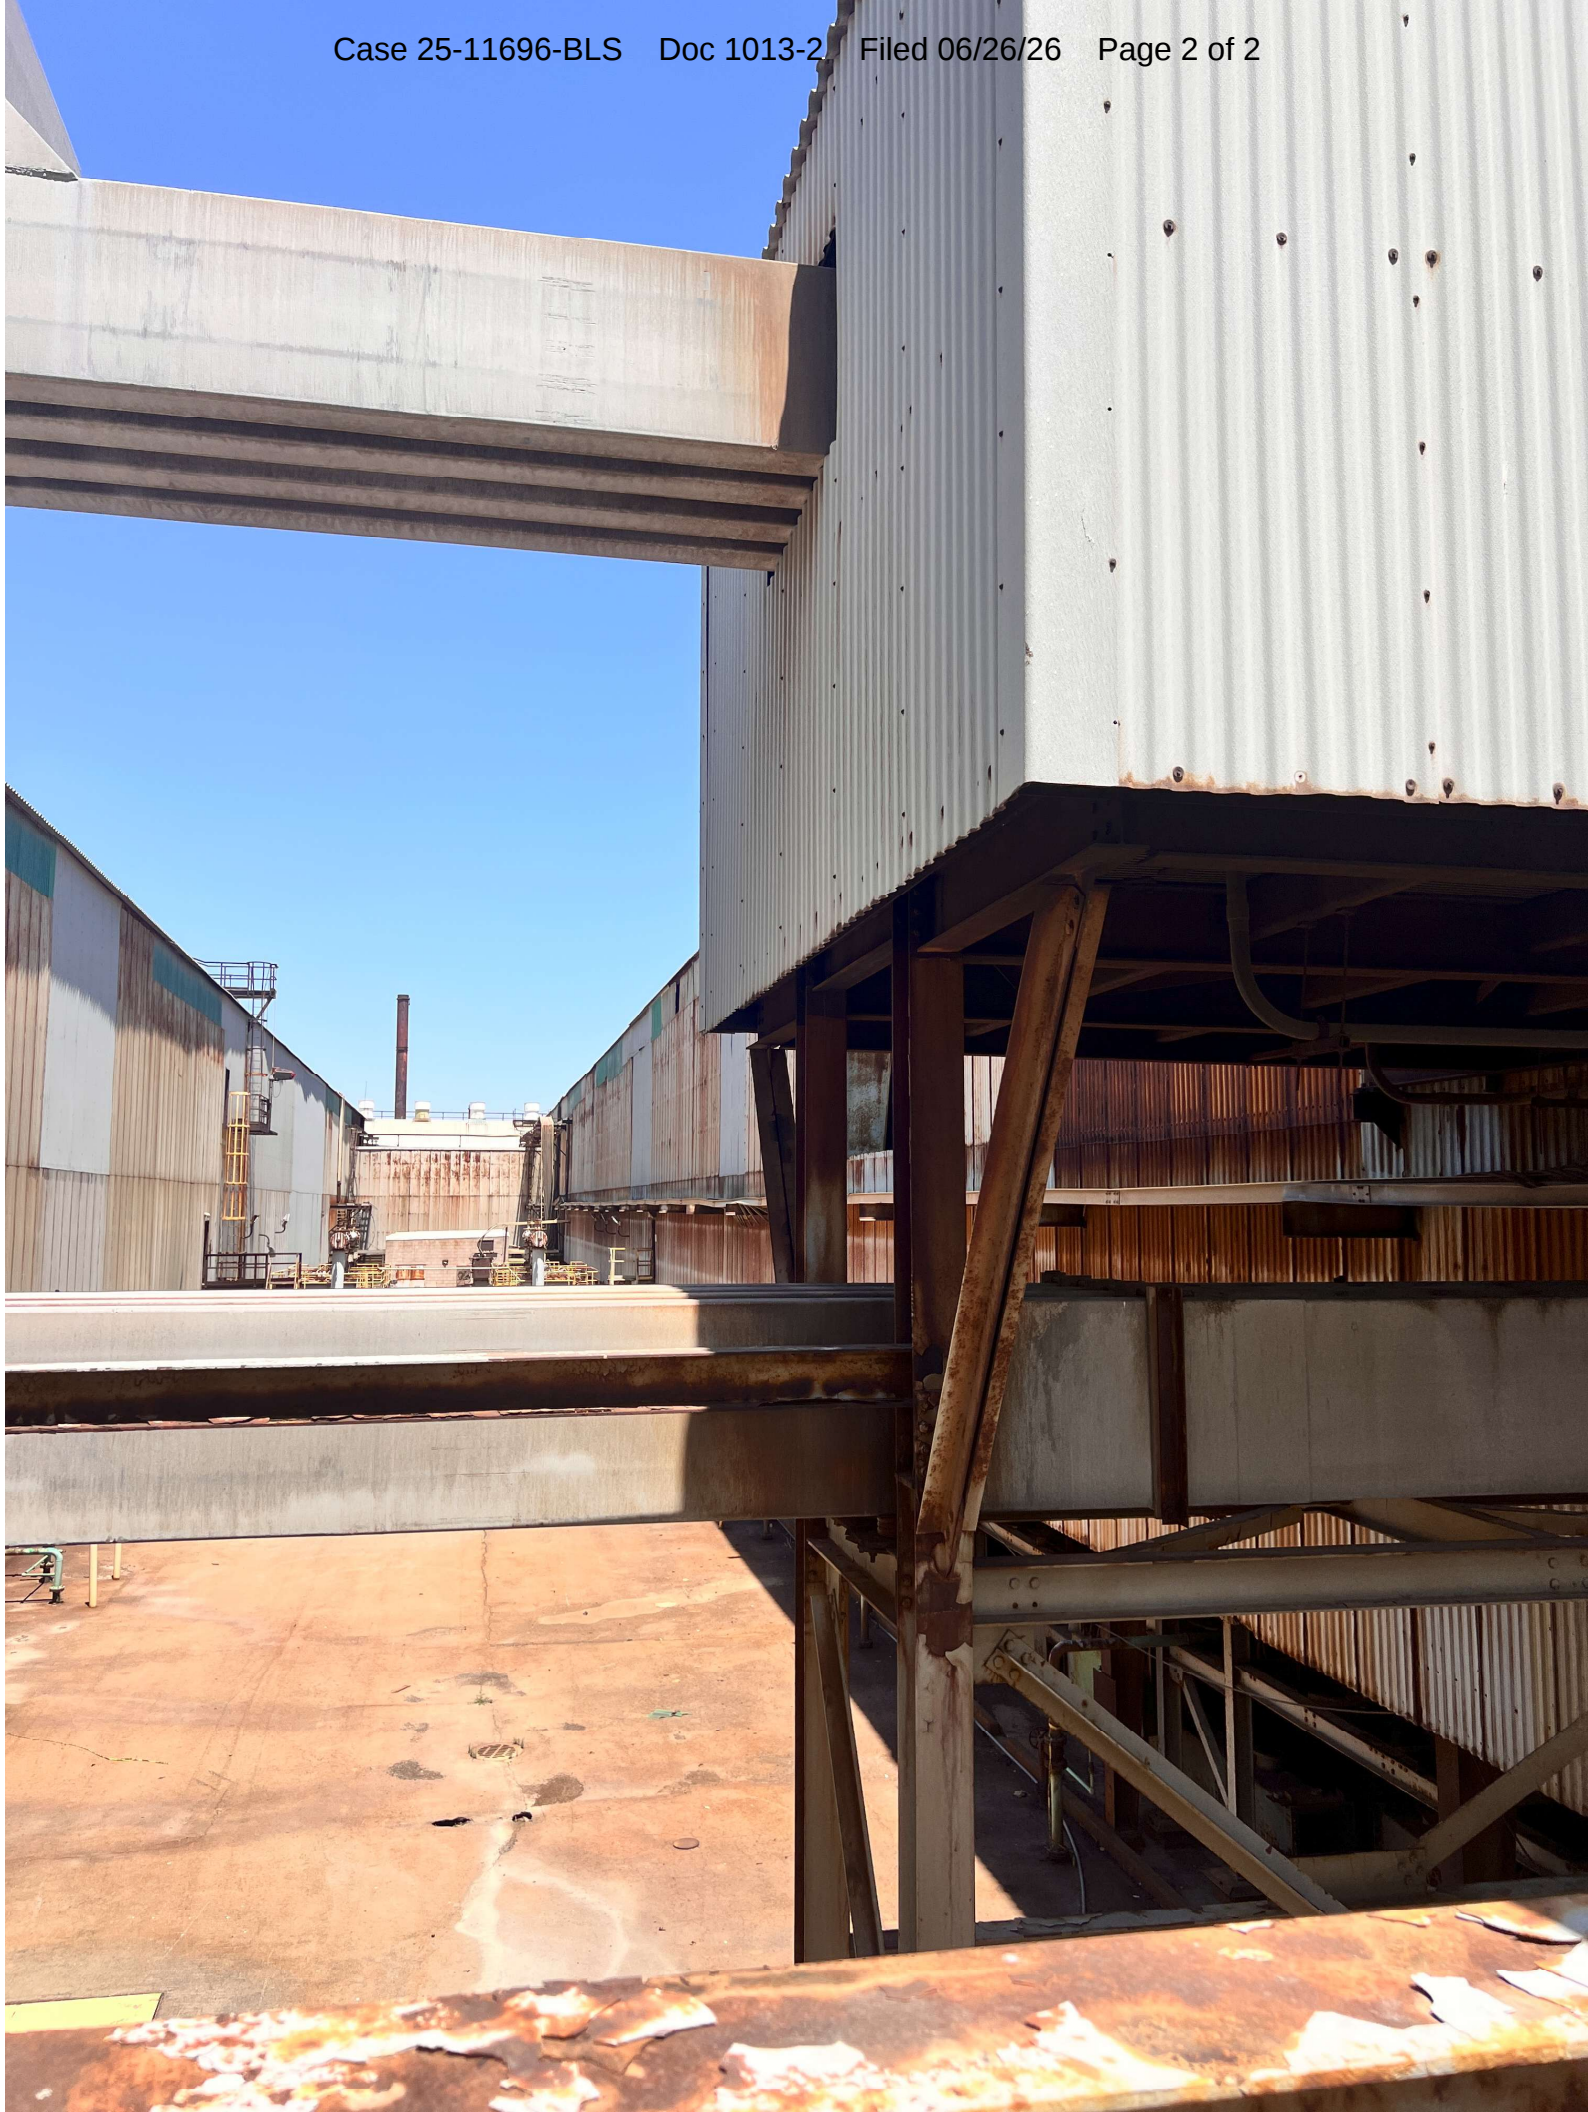
# **EXHIBIT 2**

15. Below, and attached as Exhibit “2”, is an image of the Bus Bar entering the facility.

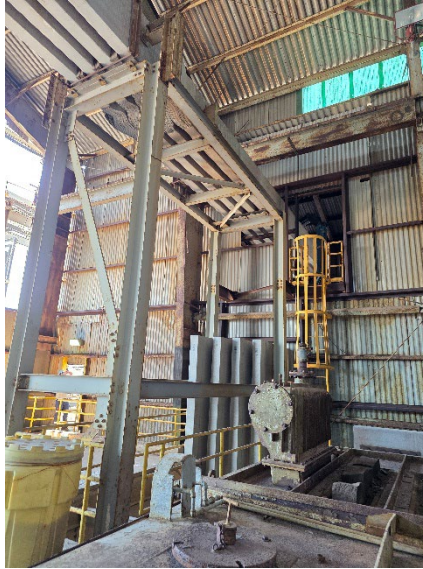
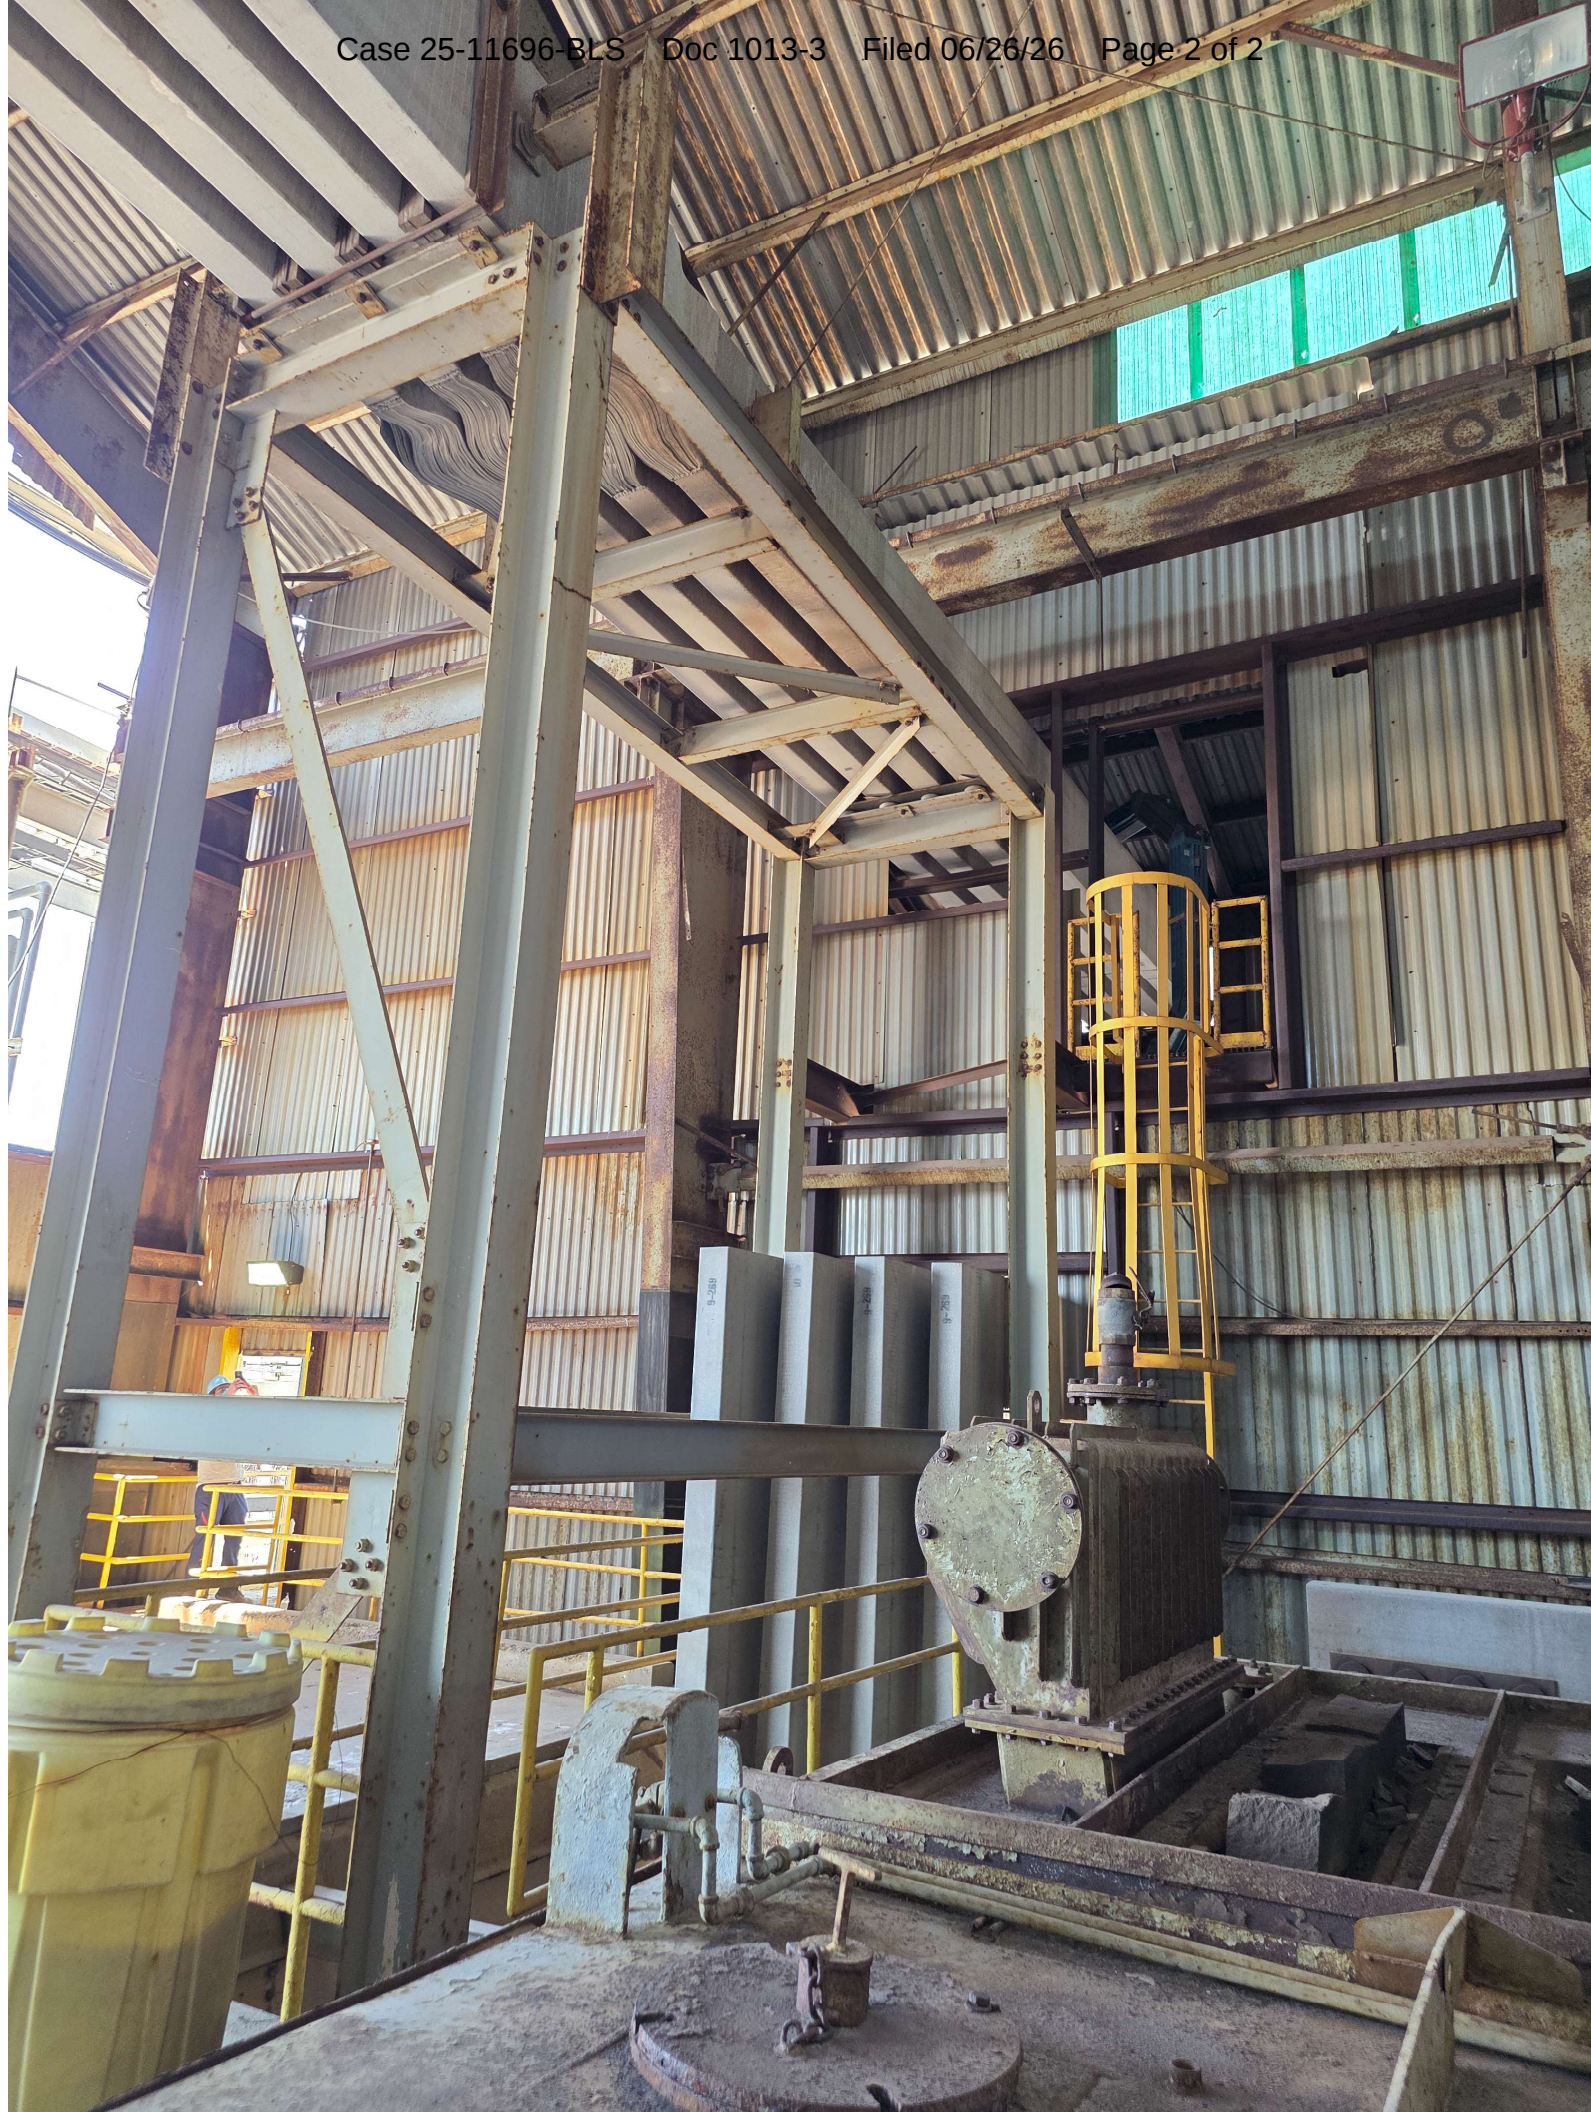
# **EXHIBIT 3**

16. Below, and attached as Exhibit “3”, is an image of the Bus Bar that shows two sections of the Bus Bar: one section of the Bus Bar that bends down to be distributed to the electrolytic cells in that wing, the “Magnesium Building One” wing, and another section of the Bus Bar that runs from the opposite side of that wing out to the second wing, “Magnesium Building Two”.

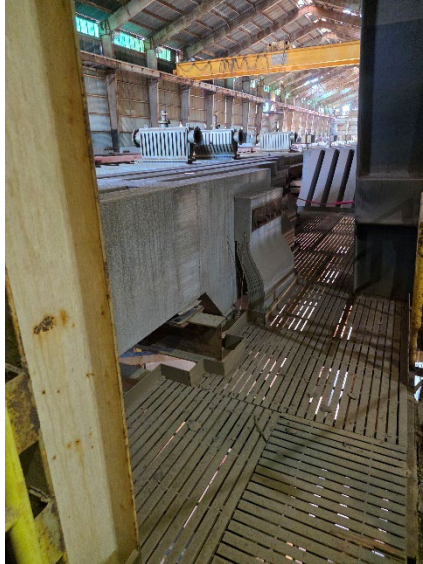
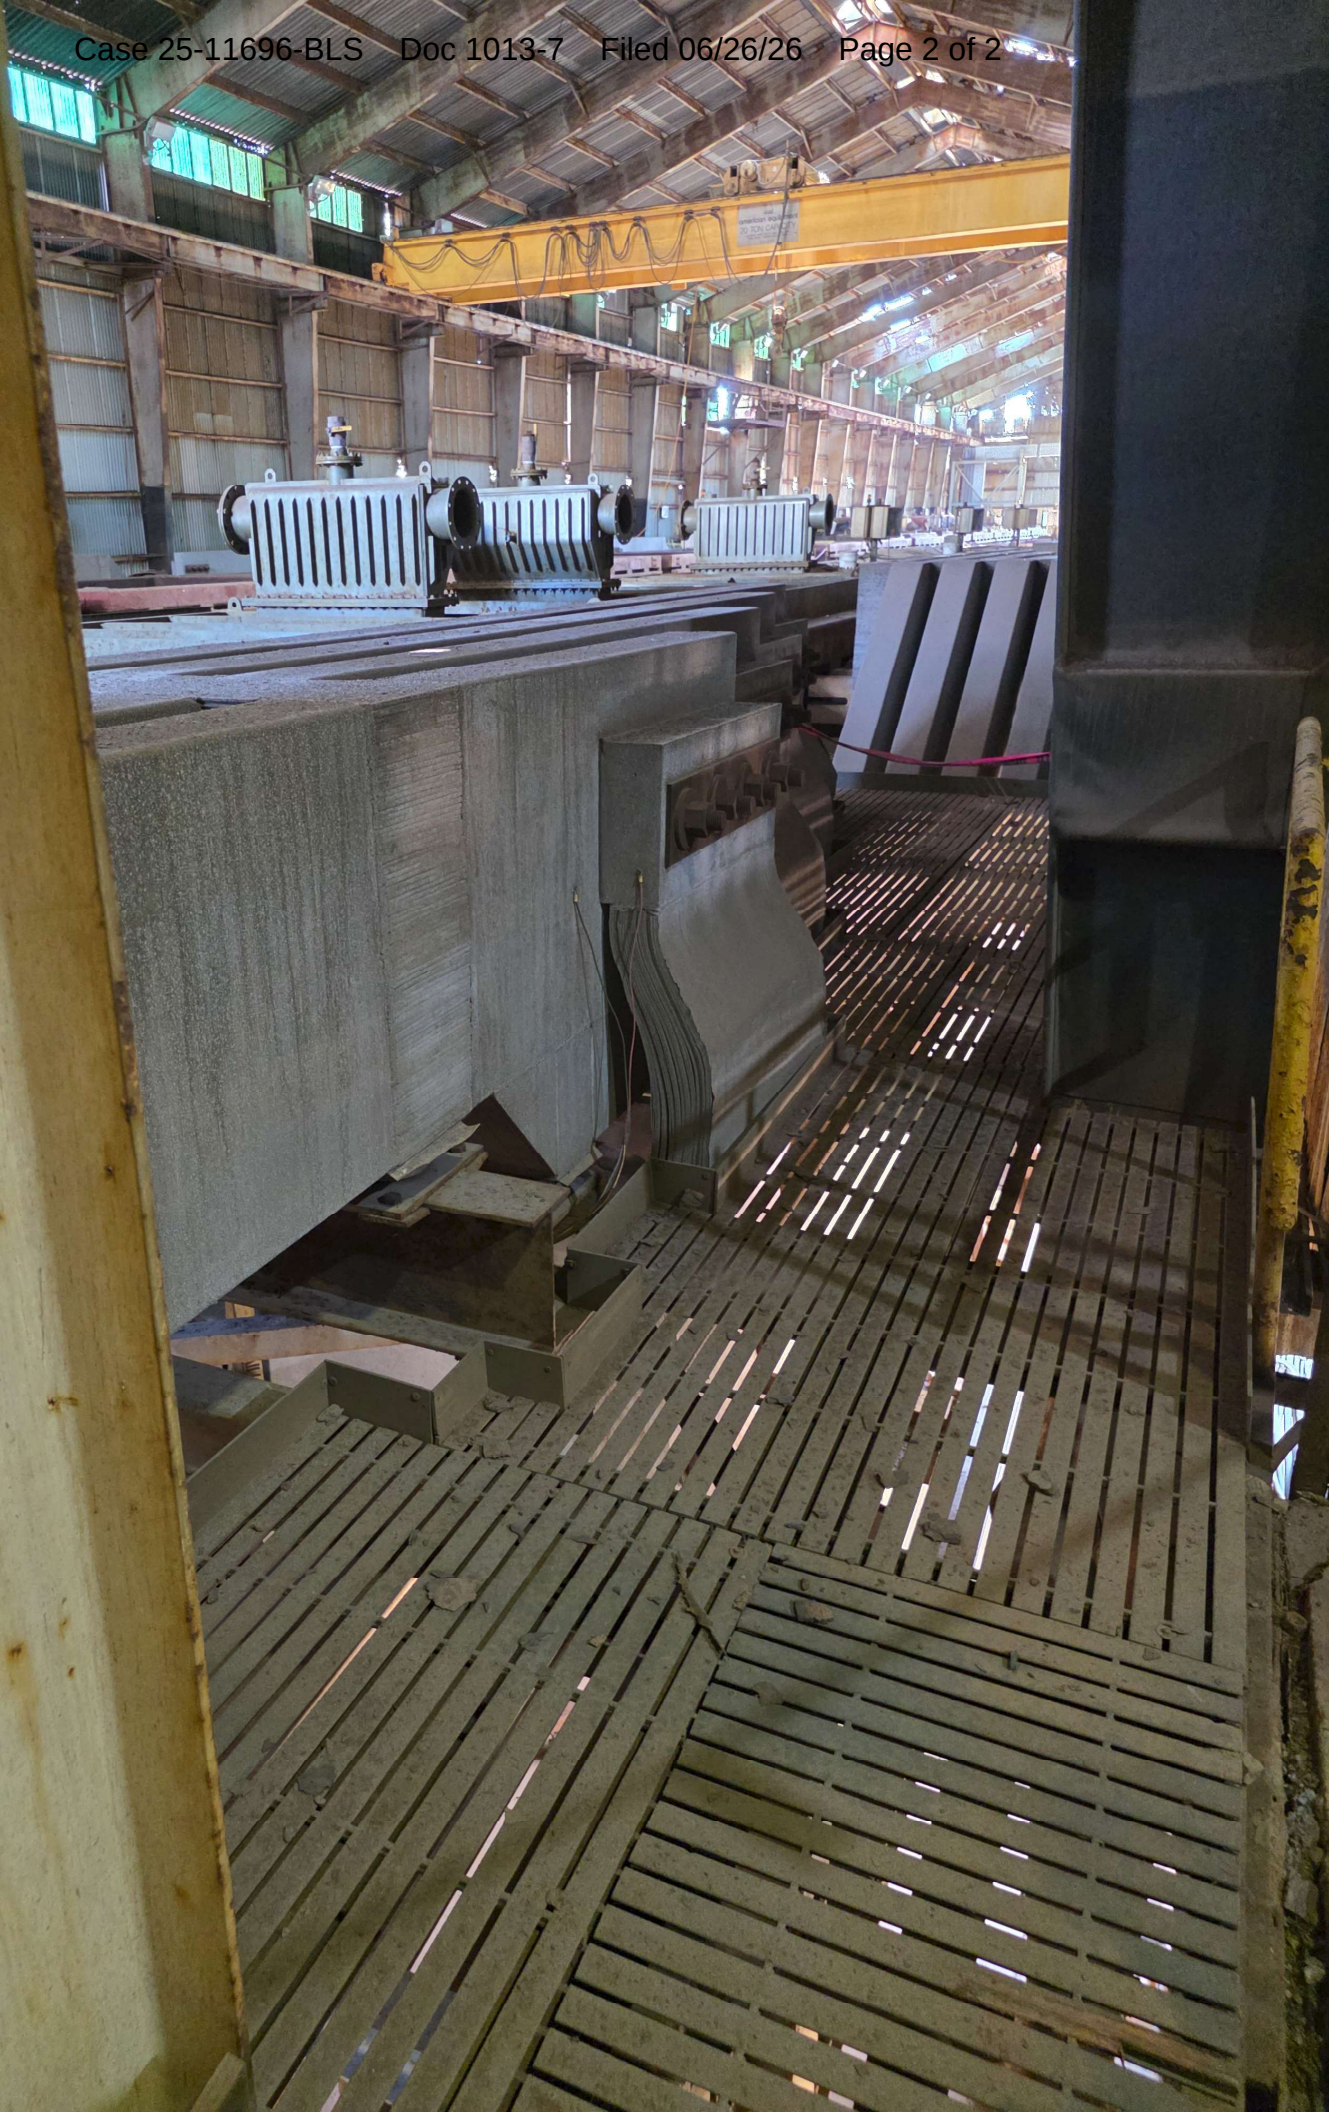
# **EXHIBIT 7**

18. Below, and attached as Exhibit “7”, is an image showing an example of the Bus Bar’s connections to individual electrolytic cells. This is an area where possible exposure to anode dust is particularly concerning.

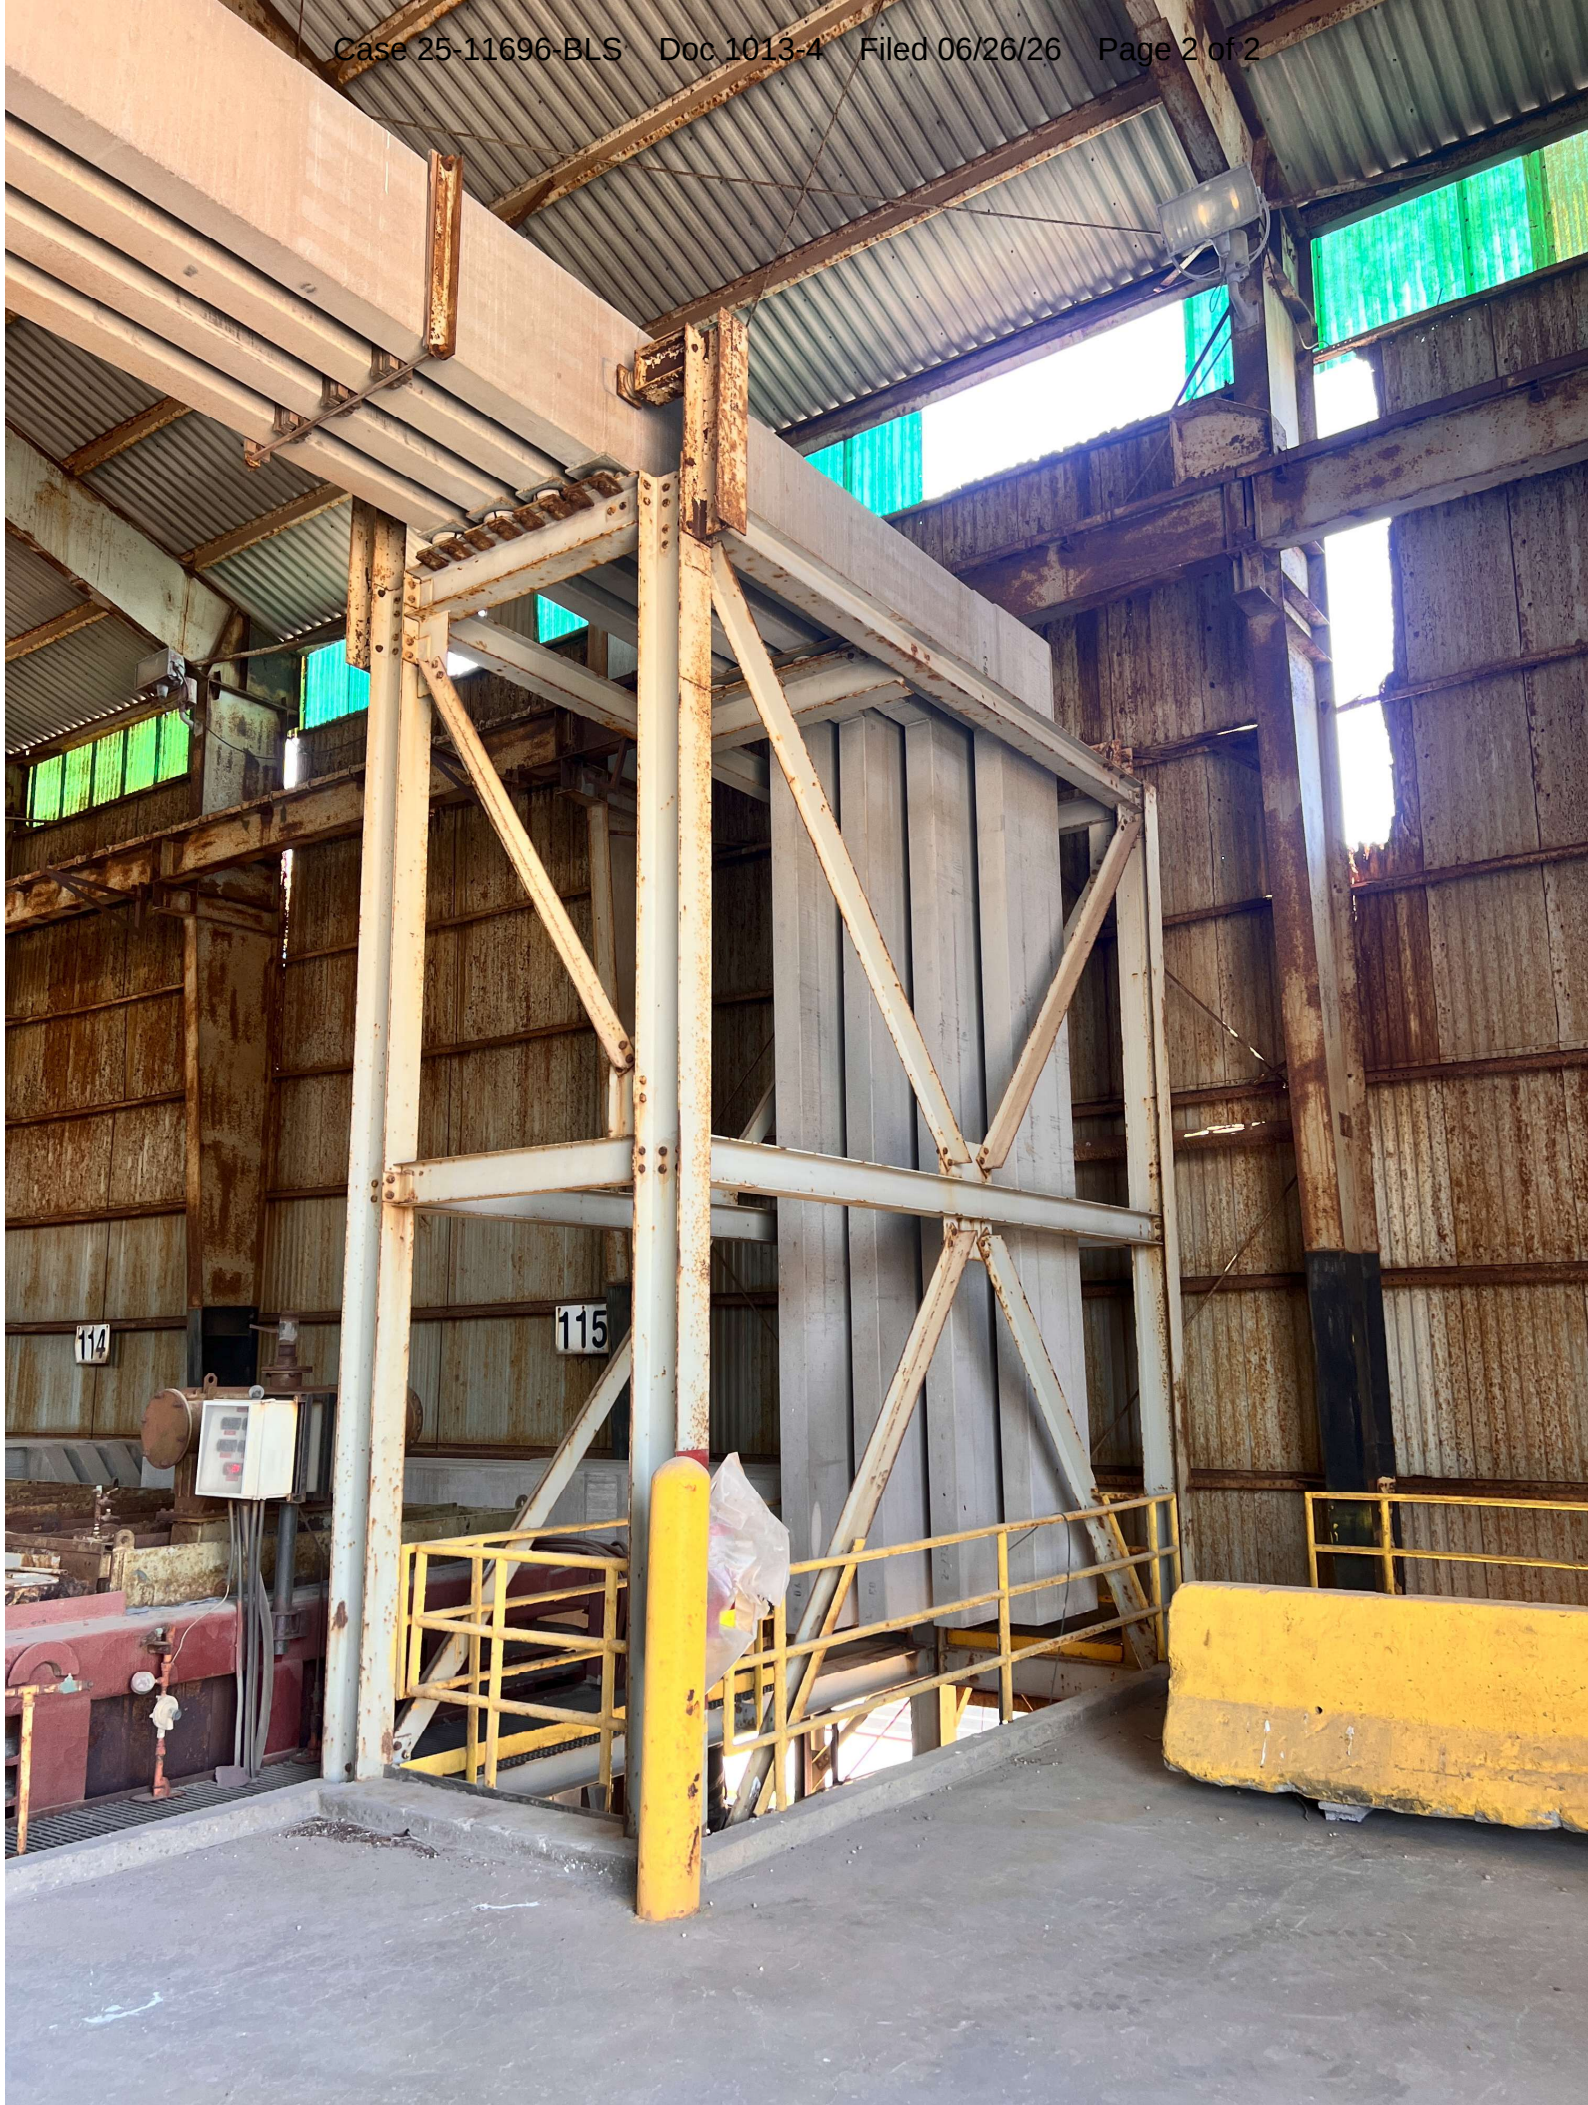
# **EXHIBIT 4**

17. Below, and attached as Exhibits “4”, “5”, and “6”, are images that show the Bus Bar after it runs the length of the wing and bends within the facility. Notably how the Bus Bar is housed within the structures of the facility, and portions of structures that will need to be removed to remove the Bus Bar.

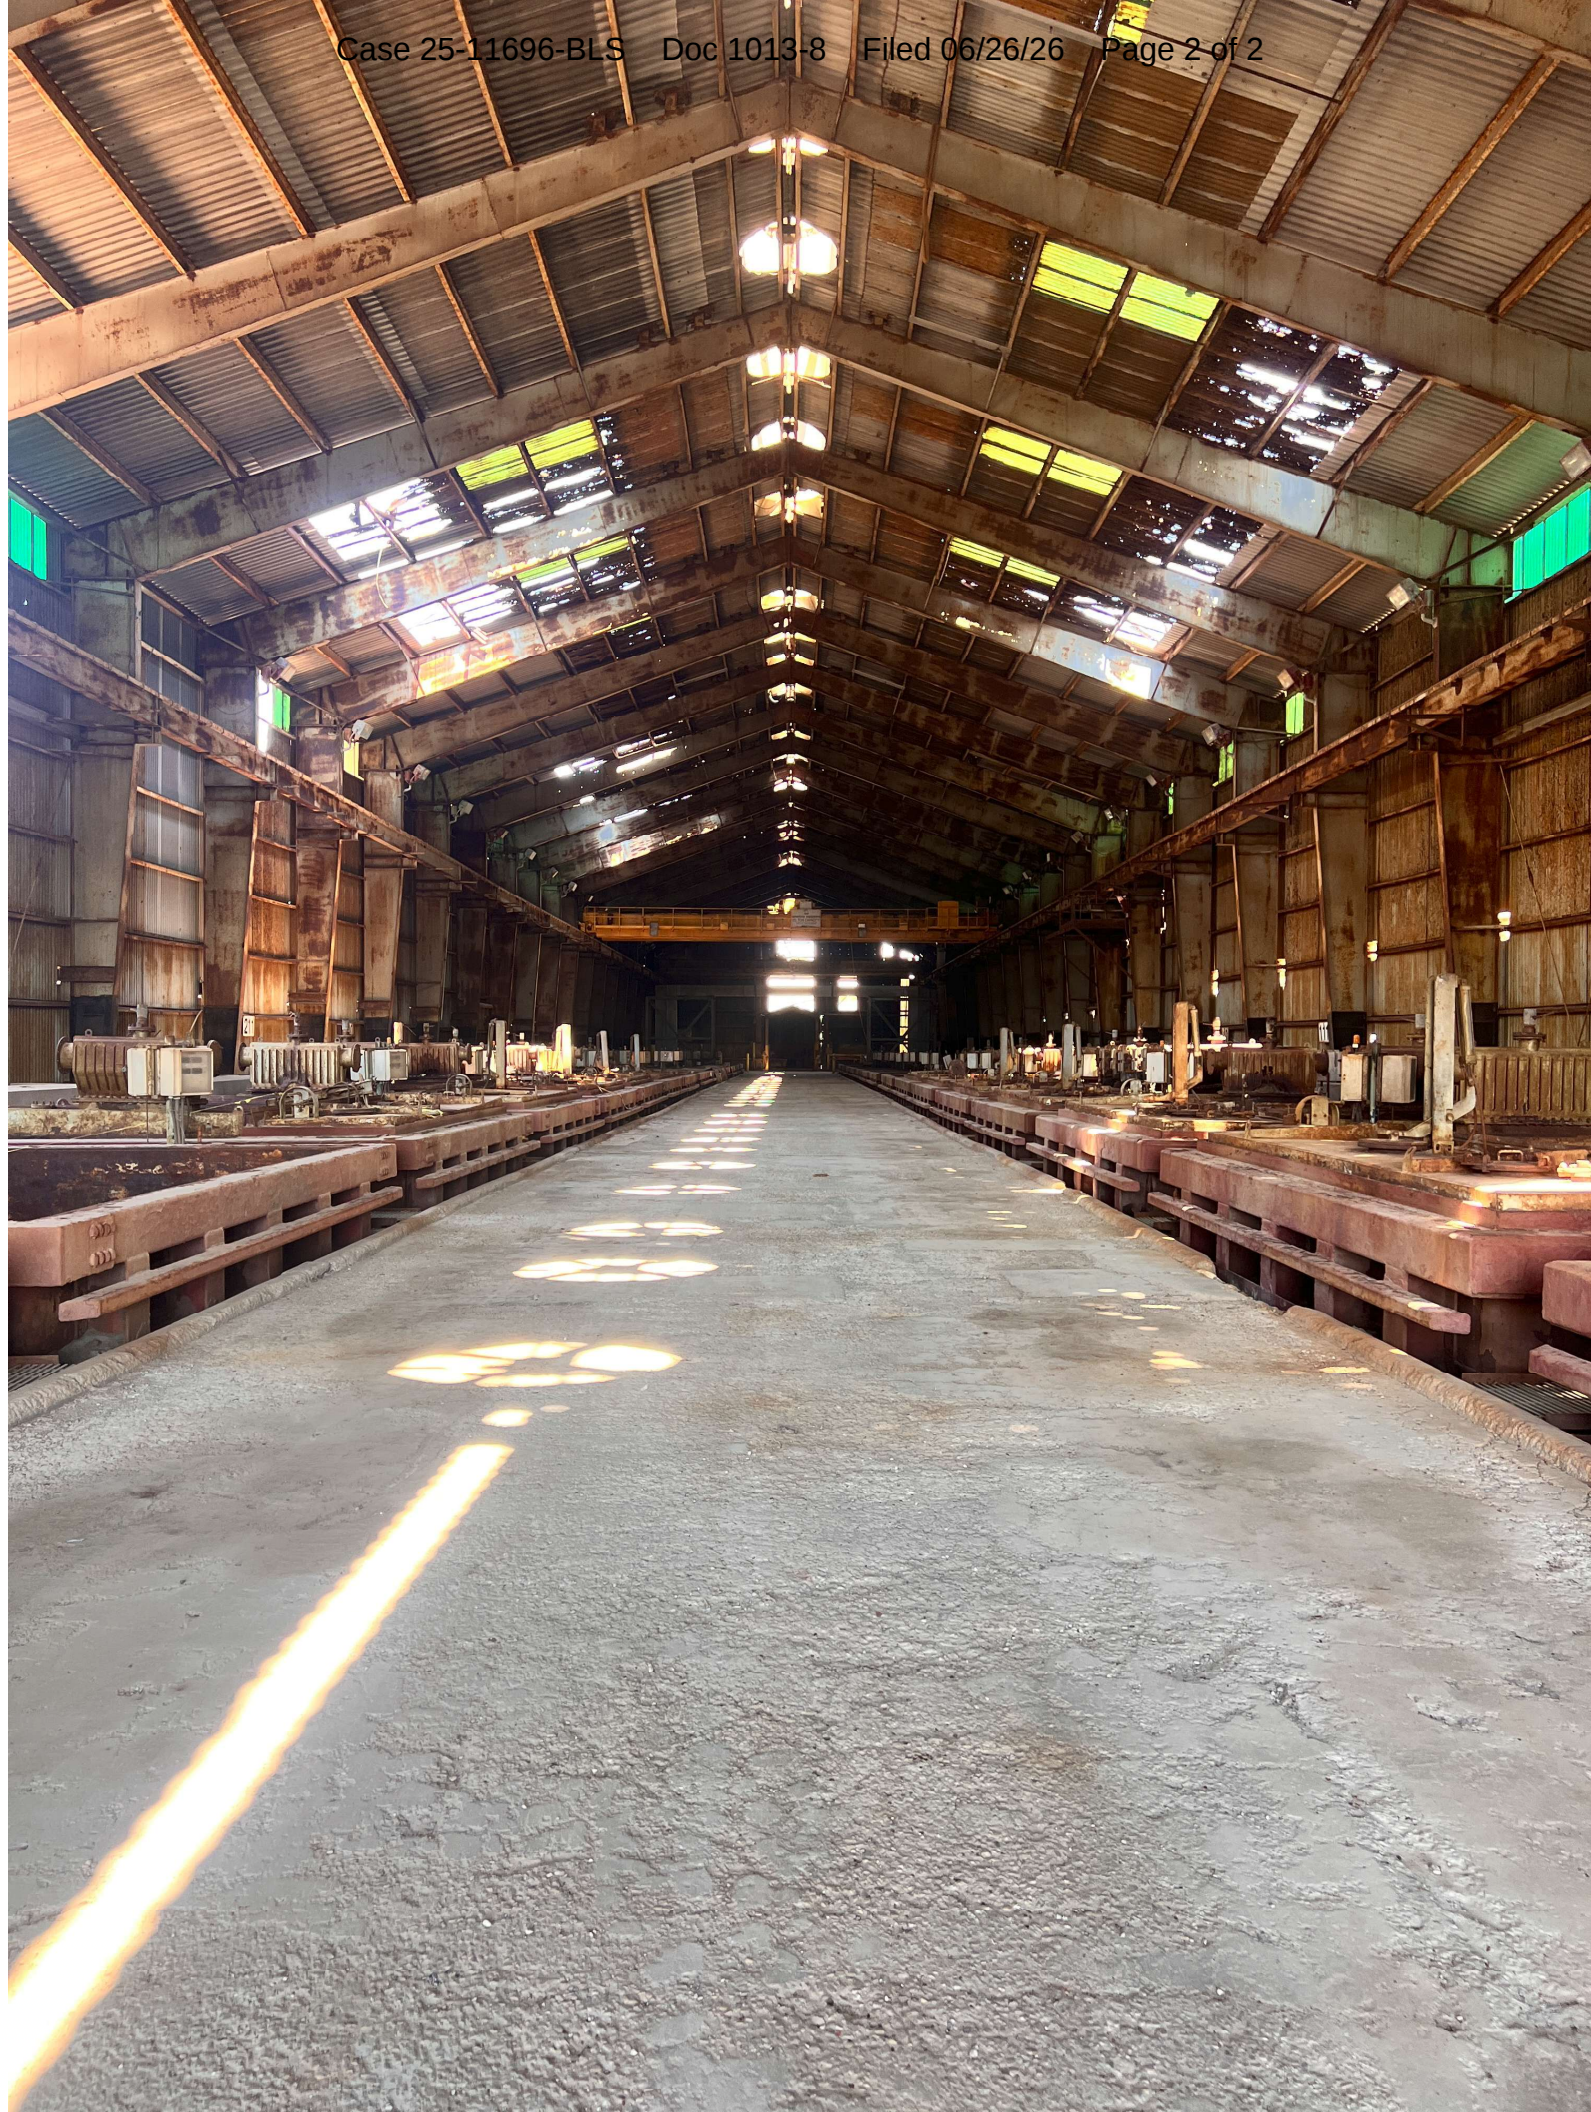
# **EXHIBIT 8**

19. Below is an image showing the interior of the wing that the Debtor refers to as “Magnesium Building One.” The wing is lined with electrolytic cells throughout its length.
